HOME INSPECTION REPORT

Wellington Park HOA

1000 Forest Park Way, Cary, NC 27518

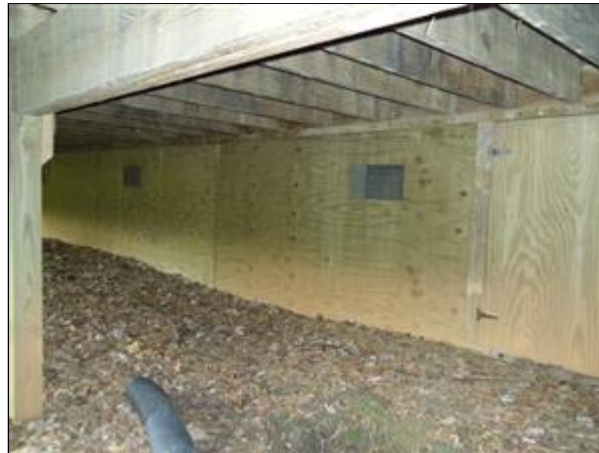
1.0 Picture 1 wood wall of foundation

The primary foundation system under the building is a block pier and wood curtain wall system. This is not a standard method of construction and due to the condition of the piers that support the building the installation of a masonry perimeter wall which can provide full support to the building should be considered. I recommend further investigation by a structural engineer or foundation specialist to provide guidance.

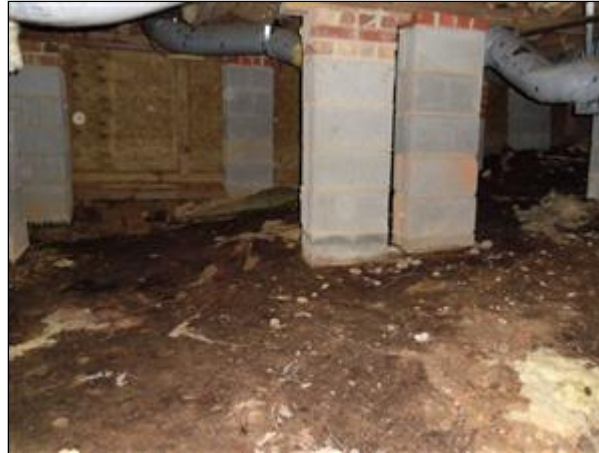
1.0 Picture 2

Active water entry is occurring in the crawlspace along the right side of the building, the ground is wet and soft. Water entry beneath the building can cause mold growths, poor indoor air quality, insect infestation, and deterioration of the wood framing. A proper masonry foundation would limit or prevent water entry. Other repairs may involve a trench drain system or regrading the right side.

Note: This issue has been occurring for some time and is not an immediate priority. Foundation repairs will likely cure this problem.

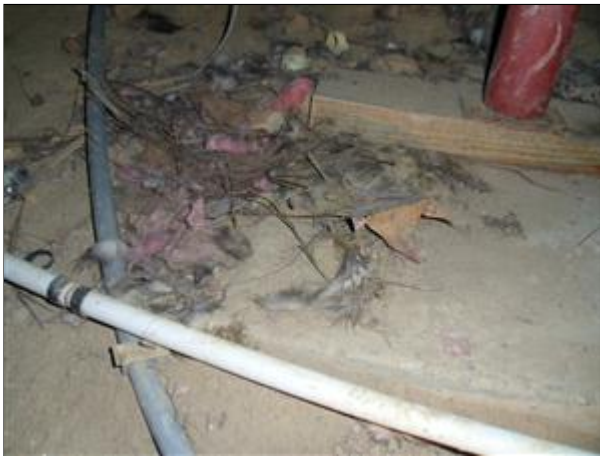
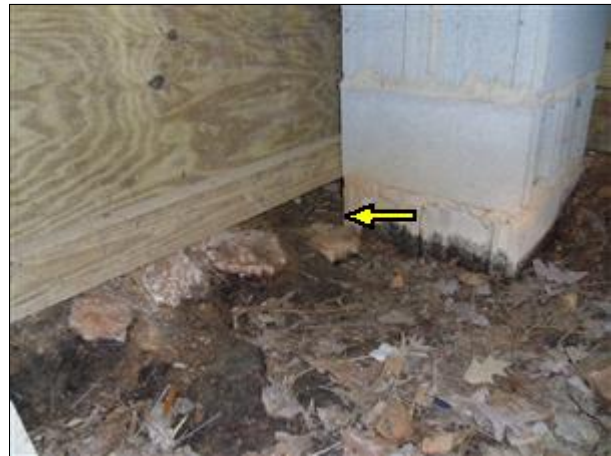
There are signs that an animal is living in the crawlspace beneath the building. There is a clear opening to the exterior at the right rear corner. Animal waste, remains, and disturbed insulation with leaves and debris are present. I recommend that the hole to the exterior be sealed and a wildlife professional remove the animal from under the building.

1.0 Picture 3 fur and nesting material

1.0 Picture 4 hole at right rear corner

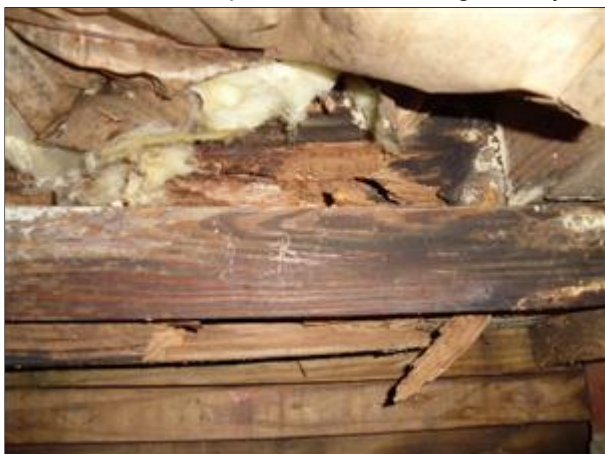
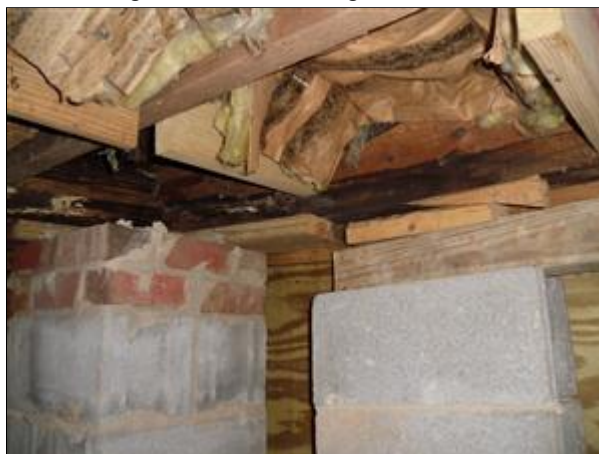
There is extensive deterioration to the floor system at the left side behind the outdoor showers. I am unable to determine if active water entry is still occurring or if this problem has been repaired in the past. Damage to the floor system is present and is in need of repair. Further investigation by a structural engineer or licensed general contractor is needed.

1.1 Picture 1 deteriorated outer band and sill

1.1 Picture 2 deterioration behind shower

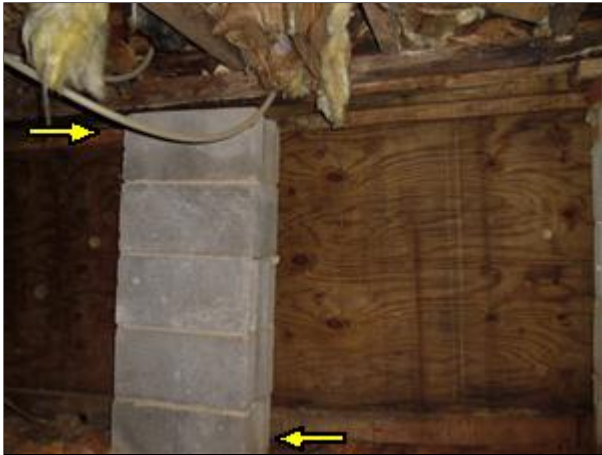
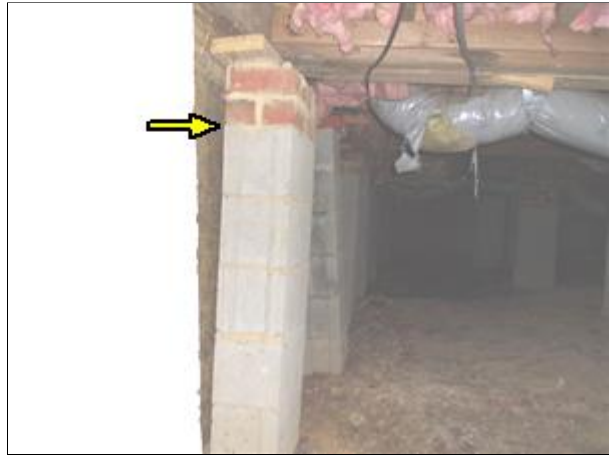
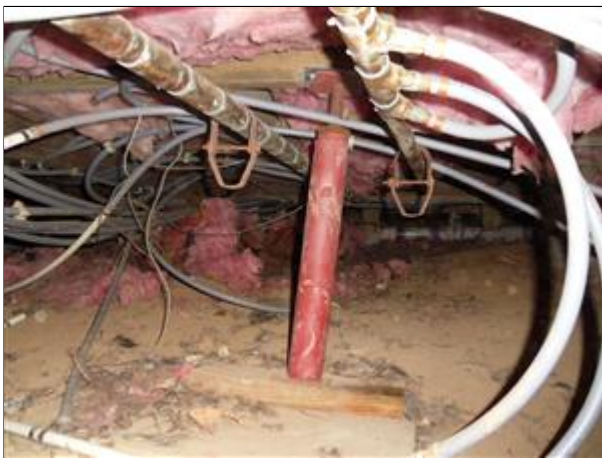
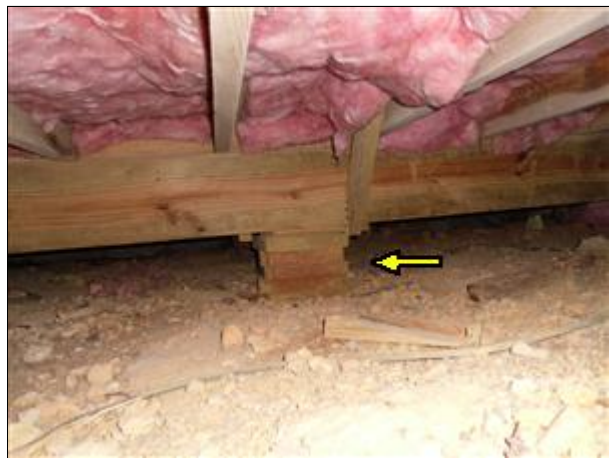
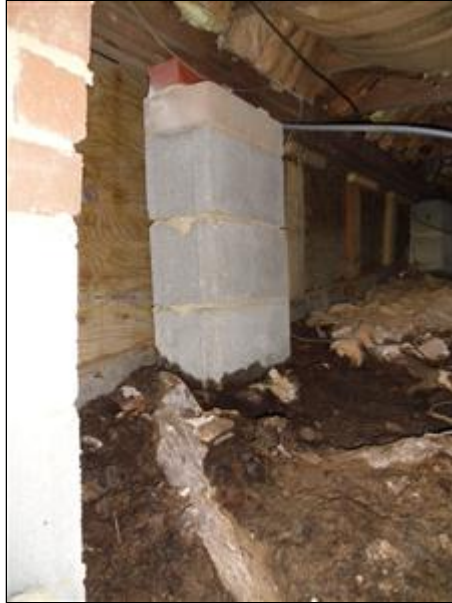
🏠 The piers that provide the structural support for the building are in disrepair and some appear to be in danger of failure. The row of concrete block piers along the rear of the building are leaning excessively, some no longer supporting the joists/beams above. Steel screw jacks have been installed near the bathrooms and are improperly sitting on wooden footings and are not providing any support to the structure. Blocks of wood in contact with the ground instead of masonry have been installed beneath the floor of the kitchen which is not a proper installation and need to be replaced. Further investigation is needed by a structural engineer to provide a plan on how best to repair the structure.

1.3 Picture 3 steel jacks

1.3 Picture 4 wood blocks

1.3 Picture 5 Field pea or moved by roots

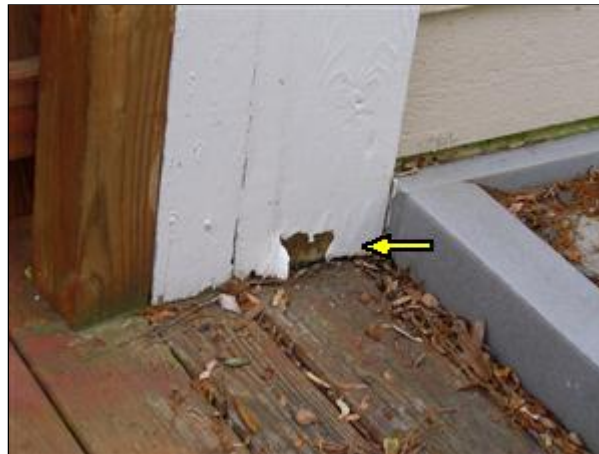
2.0 Picture 1

The lower trim at the outdoor shower has peeling paint that needs repairs to prevent deterioration.

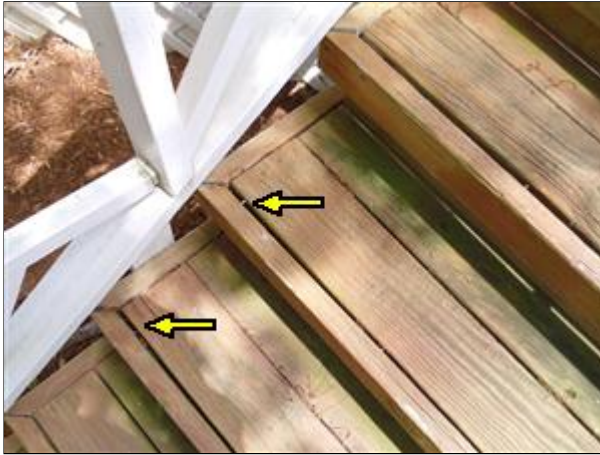
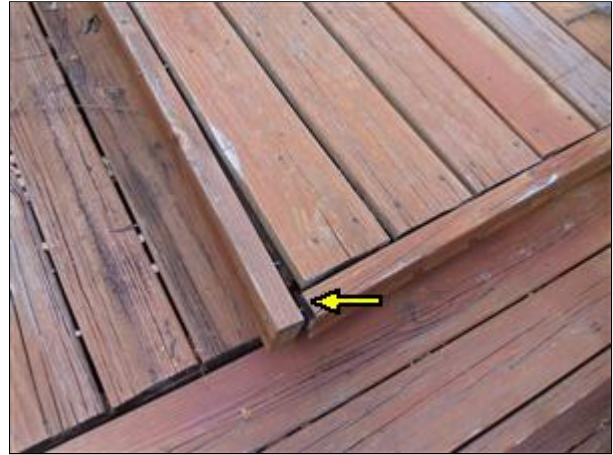
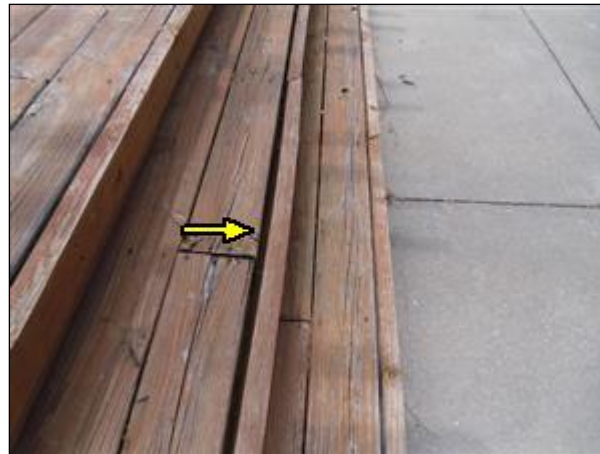
🏠 (1) The steps at the smoking areas, the pergola, barrel storage, pump house and the rear deck are in disrepair. The outer portion of the treads are detached, loose and could fail suddenly resulting in a fall or injury. Repairs or replacements are needed.

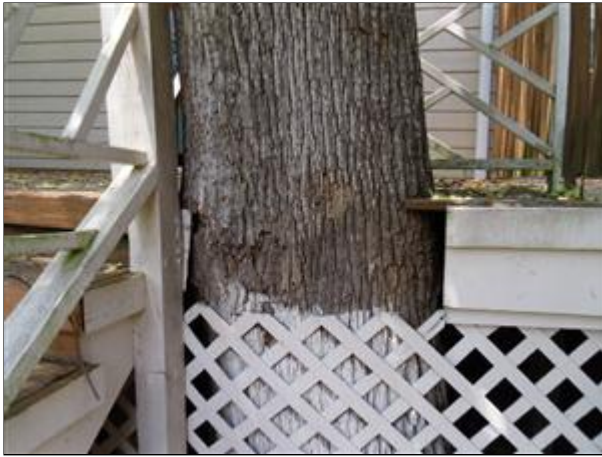
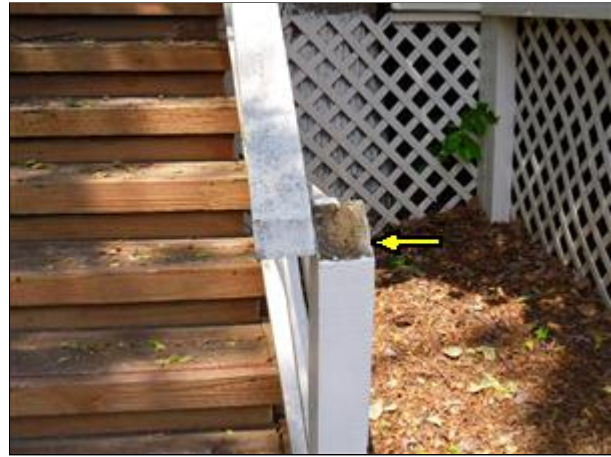
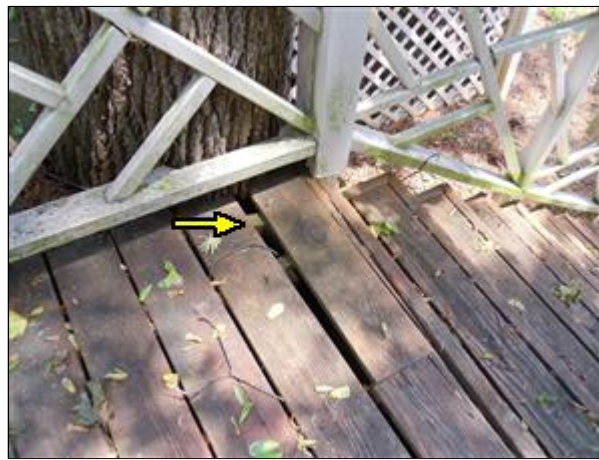
🏠 (2) The two trees growing through the rear deck are causing movement in the structure. The deck needs to be trimmed back away from the trees with allowances for further growth. The lower handrail at the rear stairway is detached and the upper attachment point has been compromised by the tree growing in this area. The deck will need structural repairs to provide support for joists or beams which may be in the way when the tree openings are enlarged. Without repairs movement in the trees can cause further damage or even catastrophic failure of the structure. Repairs by a licensed general contractor are recommended.

2.4 Picture 5 damage hand rail at back deck

2.4 Picture 6 tree causing damage

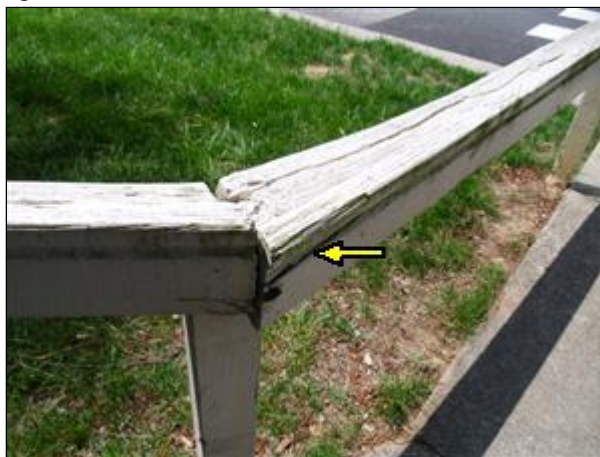
2.4 Picture 7

- 🏠 (4) The first section of handrail at the walkway leading to the crosswalk is loose and needs repairs or replacement to prevent a fall or injury from occurring.

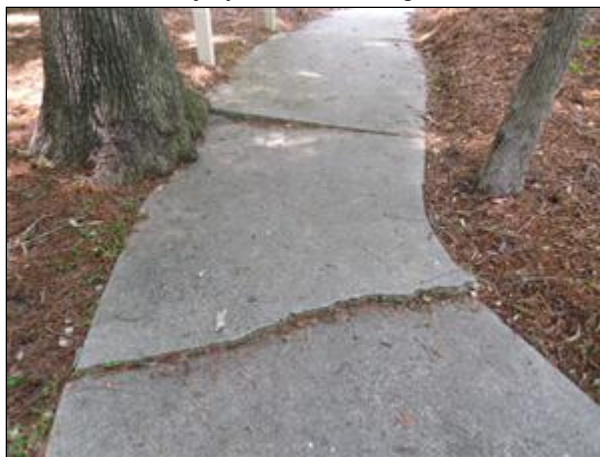
2.6 Picture 1

- 🏠 The walkway leading from the parking lot to the street crosswalk has heaved and settled creating an unsafe surface and needs repairs or replacement to prevent a fall or injury from occurring.

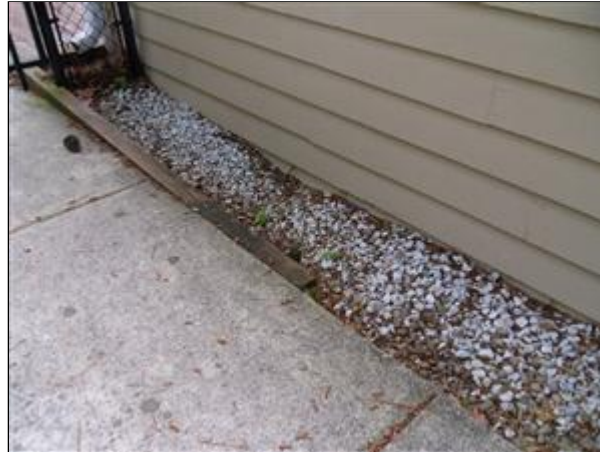
2.7 Picture 1

The gravel and dirt along the pool gate entrance walkway is too high and is contact with the wood siding. The grade needs to be lowered to maintain 6-8" of clearance to the lower row of siding. Continued ground contact will result in deterioration and insect damage to the structure.

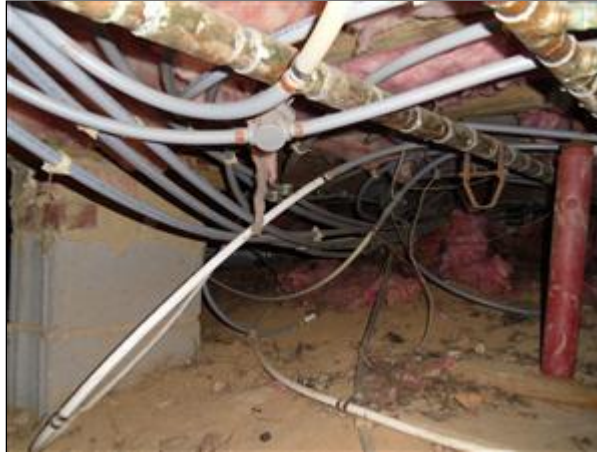
4.0 Picture 1

(1) The plumbing supply lines serving the bathrooms are not properly supported or routed in a manner that would enable identification or servicing individual fixtures. Several of the polybutylene supply lines have been previously repaired indicating prior failures have occurred with the piping. The replacement of the polybutylene supply lines should be considered along with the extensive remodeling plans that are under consideration for the bathrooms.

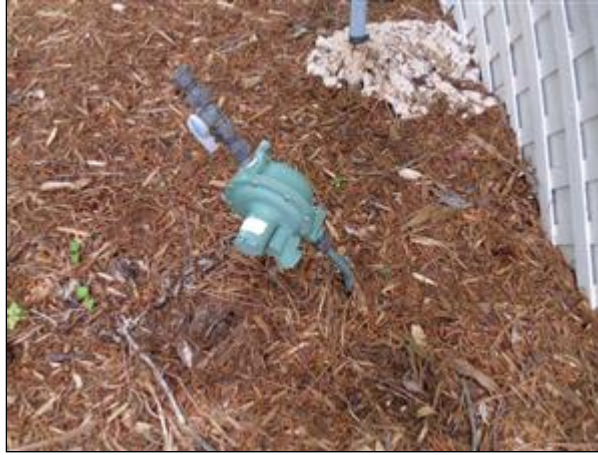
4.3 Picture 1

The old propane connection at the right side where the gas meter is located is damaged, the line is kinked and no longer usable. I recommend the removal of the line and regulator to prevent injury.

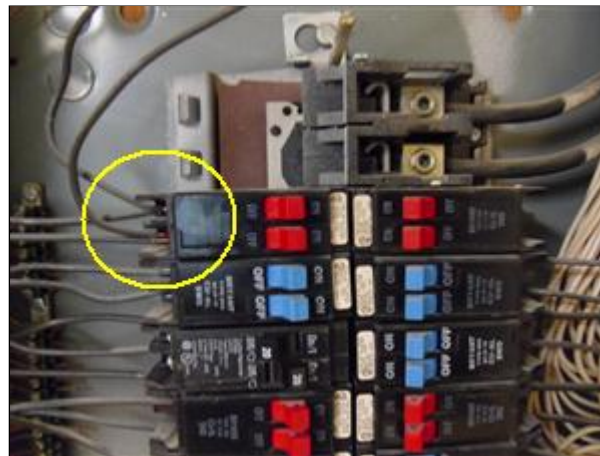
5.2 Picture 1

There is a double tapped a circuit breaker at the upper left of the kitchen electrical panel. This is a wiring defect that needs repairs by a licensed electrician. There are other unused breakers that can be utilized in the panel.

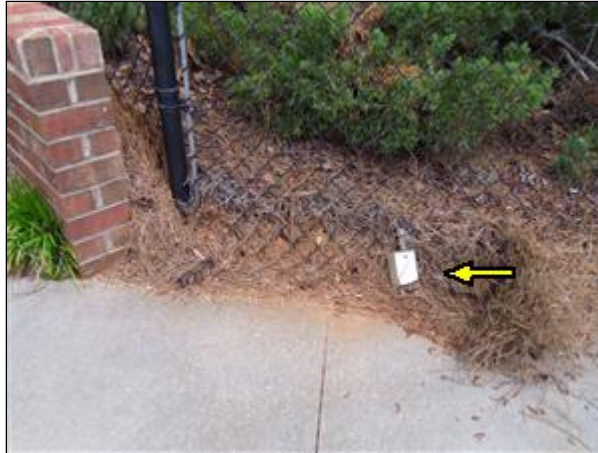
5.3 Picture 1

- 🏠 (1) There is a damaged electrical box at the pool slide that has corroded through and has visible wiring present. Repairs by a licensed electrician are needed to prevent accidental contact and injury.

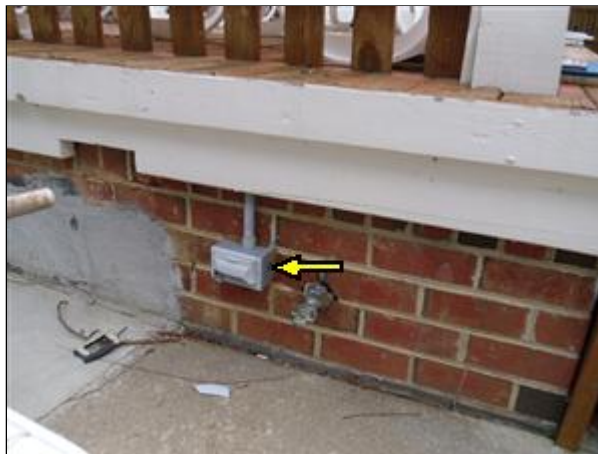
5.5 Picture 1

- 🏠 The GFCI receptacle on the left side of the raised pergola has a damaged cover and does not respond to GFCI testing. Repairs by an electrician are needed.

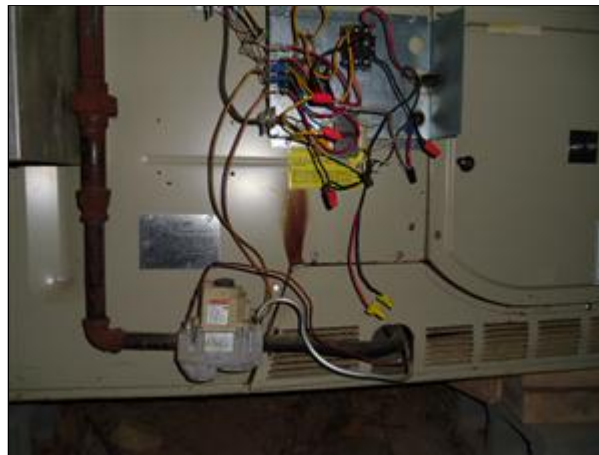
6.0 Picture 1

The HVAC system in the building appears to be in excess of 20 years old and according to the National Association of Home Builders these units have a life expectancy of 10-20 years. Signs of rust on the heat exchangers and corrosion/oxidation on the outer cabinets was observed, the control wiring is in disarray and the duct system is in disrepair. This inspection is not a technically exhaustive evaluation of any part of the building. While the unit produced adequate heat and functioned properly, the outward condition of the unit suggests that replacement is needed. I recommend further investigation by a licensed HVAC contractor to determine if a cracked heat exchanger is present which is a carbon monoxide hazard and to provide replacement costs for the entire system.

High Priority for repair prior to the heating season.

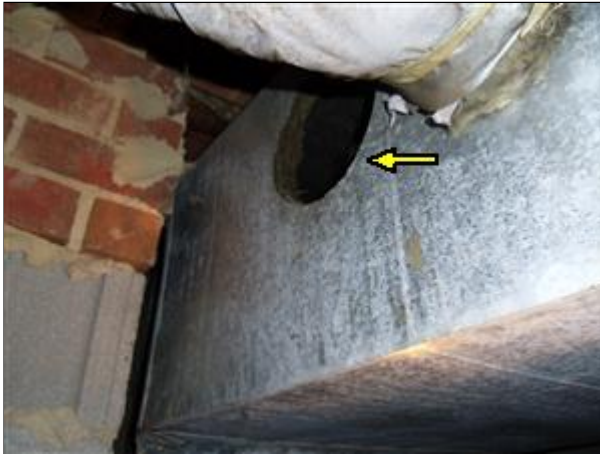
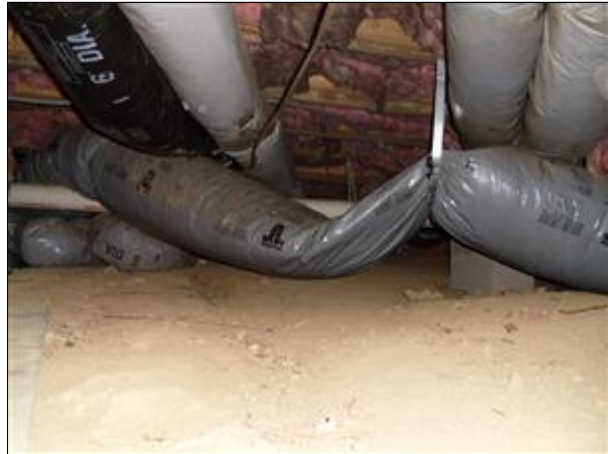
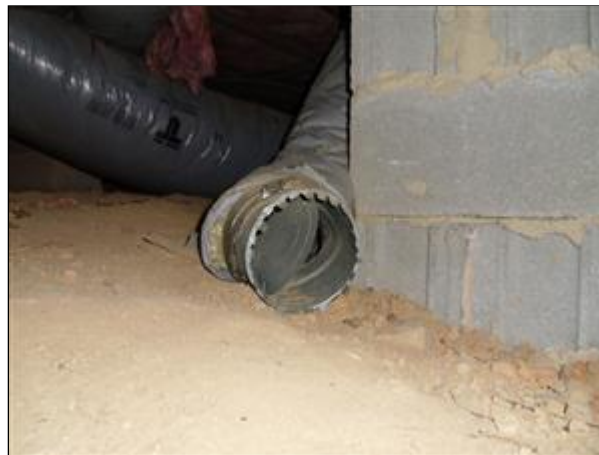
The ductwork under the building is in need of extensive repairs or full replacement. There is a disconnected duct at the main plenum which is causing a drastic loss in efficiency and energy. The return duct into the main room of the clubhouse is crushed and can no longer draw air. Many of the supply ducts are crushed or kinked and no longer supply air. The replacement of the ductwork with new material and sealing all joints will provide a dramatic boost in efficiency and decreased operating costs. I recommend a licensed HVAC contractor repair or replace all the ductwork under the building.

Mixed Priority: Small operational repairs should be made now to save on operating costs and full replacement when the entire system is replaced.

6.3 Picture 1 open supply hole

6.3 Picture 2 crush return duct

6.3 Picture 3 disconnected supply duct

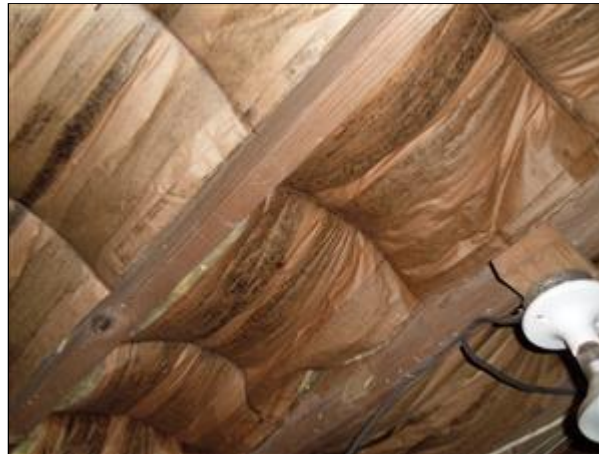
9.1 Picture 1 insulation upside down

- 🏠 The floor system insulation has been improperly installed, inadequately sized, and has fallen or is missing and many areas under the building. I recommend repairs or replacement of all insulation under the floor system to provide for better energy efficiency. Repairs by a professional insulation contractor are recommended.

Low Priority: Repair after crawlspace environment is improved.

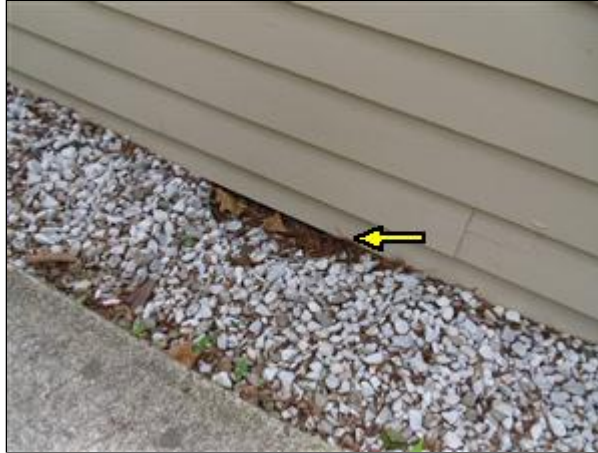
9.3 Picture 1

The crawlspace vents along the pool entrance walkway are partially or completely blocked with debris. The vent closest to the gate is no longer visible due to gravel cover. The vents need to be cleared of all debris and if needed have larger wells installed to prevent blockage. Inadequate ventilation can cause high moisture levels, mold growths and deterioration of the framing under the building.

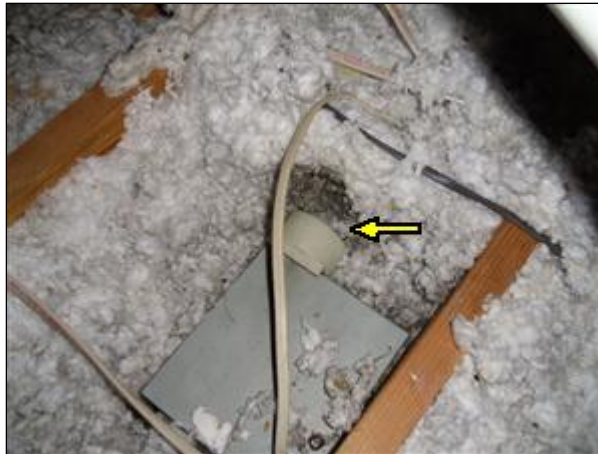
9.4 Picture 1

One of the bathroom fans in the men's room and one of the bathroom fans in the women's room is not connected to the exterior and needs repairs to prevent the accumulation of moist air in the attic space.
