HOME INSPECTION REPORT

Wellington Park HOA

1000 Forest Park Way, Cary, NC 27518

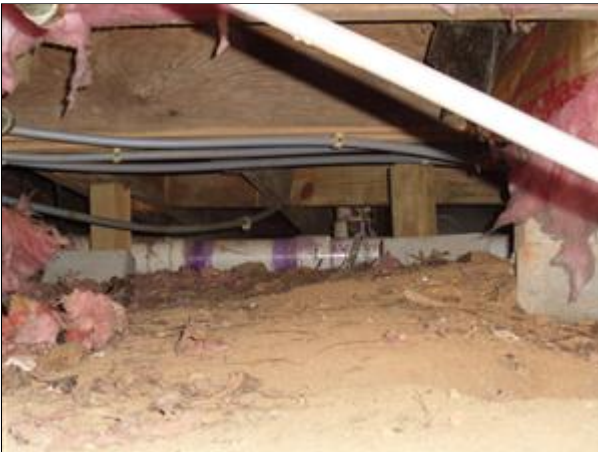
The crawlspace was entered through the access door at the rear of the home and was inspected with a flashlight and probe. Moving insulation only where required by the [NCHILB SOP](#). Areas above any air handlers, duct work, pipes and wiring were not visible and not inspected. The crawlspace under the kitchen, men's room, and the women's room were too low to be accessed safely, these areas were not entered.

1.6 Picture 1 crawlspace under the women's bathroom

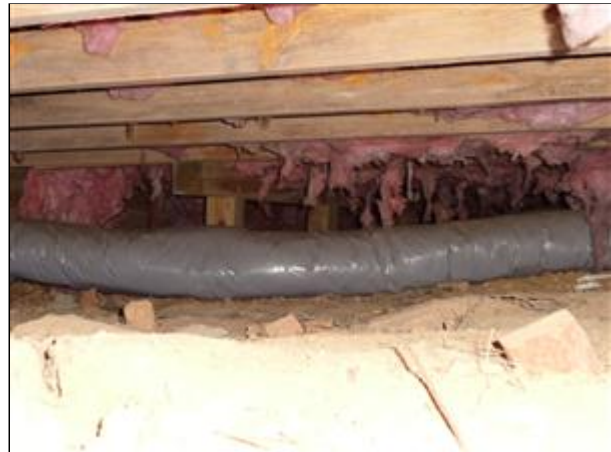
1.6 Picture 2 crawlspace under the kitchen
